WYACONDA CITY DAM
CLARK COUNTY, MISSOURI
MO 10009

**PHASE I INSPECTION REPORT
NATIONAL DAM SAFETY PROGRAM**

PREPARED BY: U. S. ARMY ENGINEER DISTRICT, ST. LOUIS

Name of Dam: Wyaconda City Dam, Missouri Inv. No. 10009
State Located: Missouri
County Located: Clark
Stream: Unnamed Tributary of the South Wyaconda River
Date of Inspection: September 27 & 28, and October 5, 1978

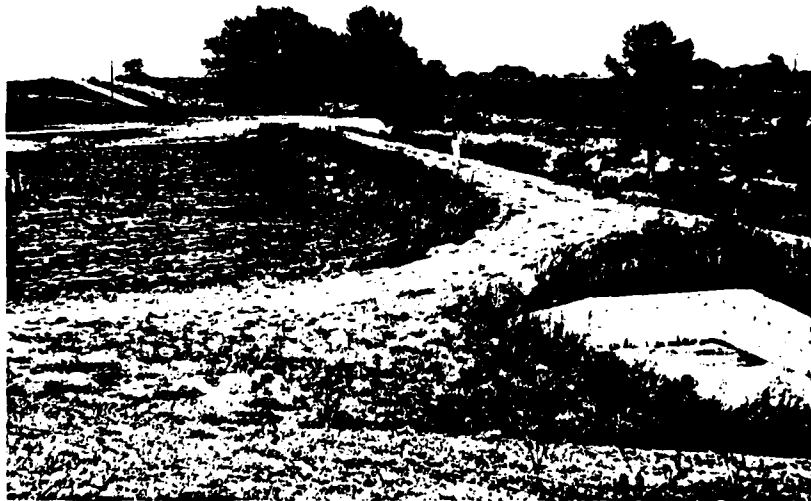
Photo 1 - View across spillway and along crest taken at right abutment.

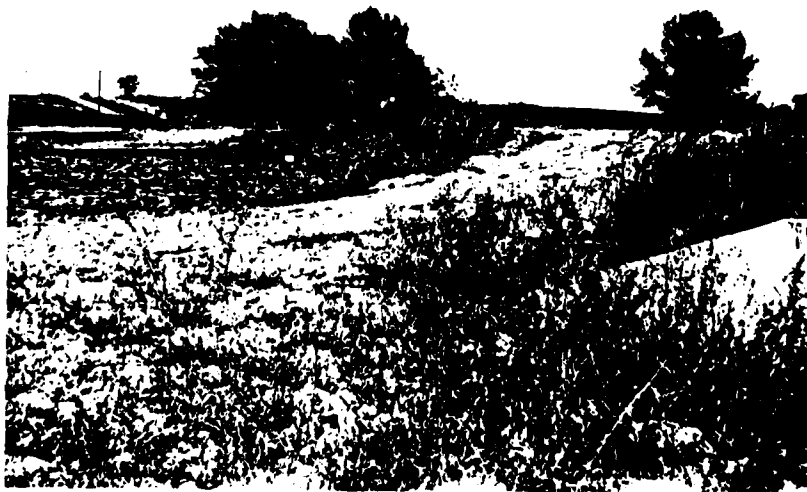
Photo 2 - View along upstream slope of embankment taken at spillway crest.

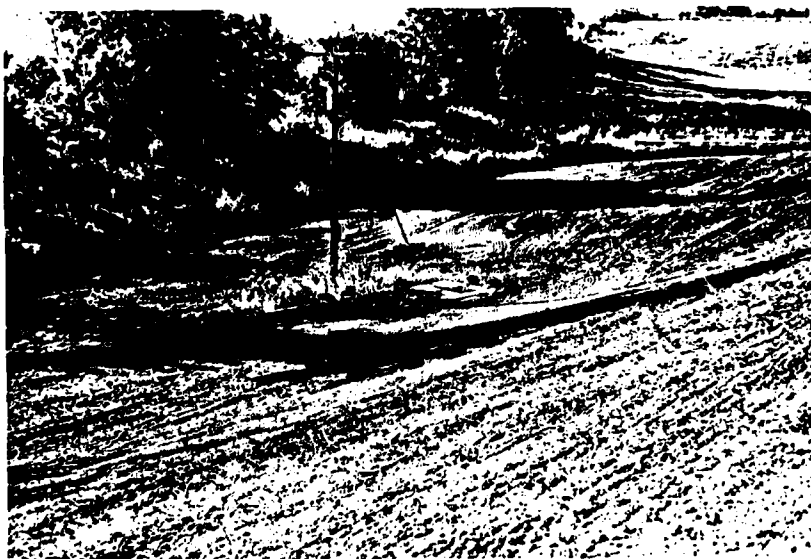
Photo 5 - View along downstream slope of embankment taken at left abutment.

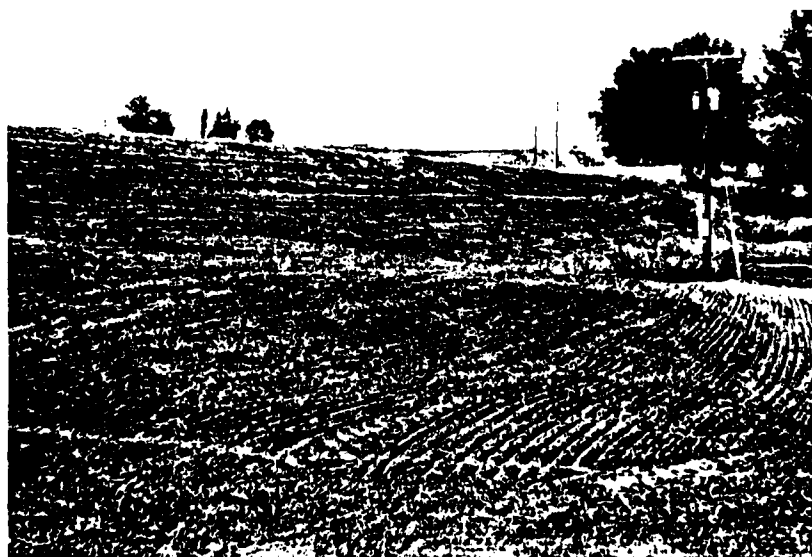
Photo 6 - Picture of downstream slope of embankment taken downstream of the dam.

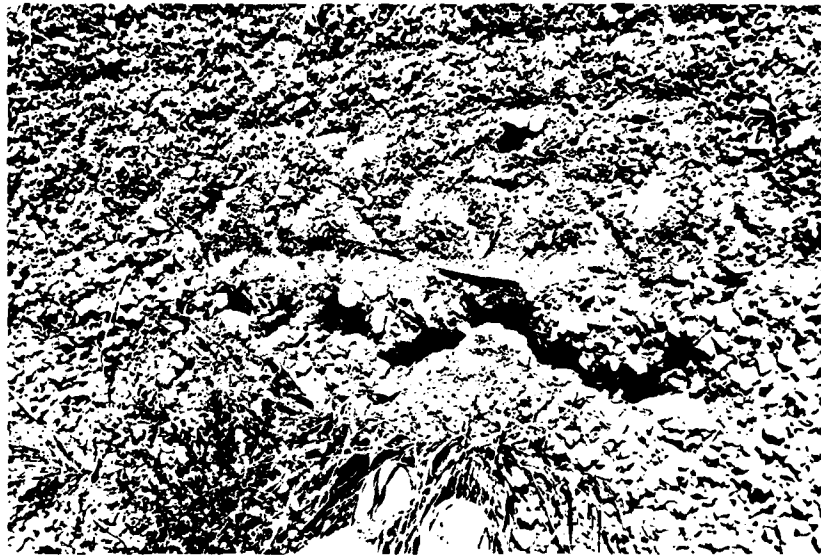
The crest of the dam is protected with a thin layer of gravel base material. A crack could be seen along virtually the entire length of the crest on each side of the new core. The crack was up to 1-inch wide in some places.

Photo 7 - Close-up of cracking near downstream edge of crest.

c. The cracking along the crest of the embankment should be corrected to prevent surface waters from entering the embankment.

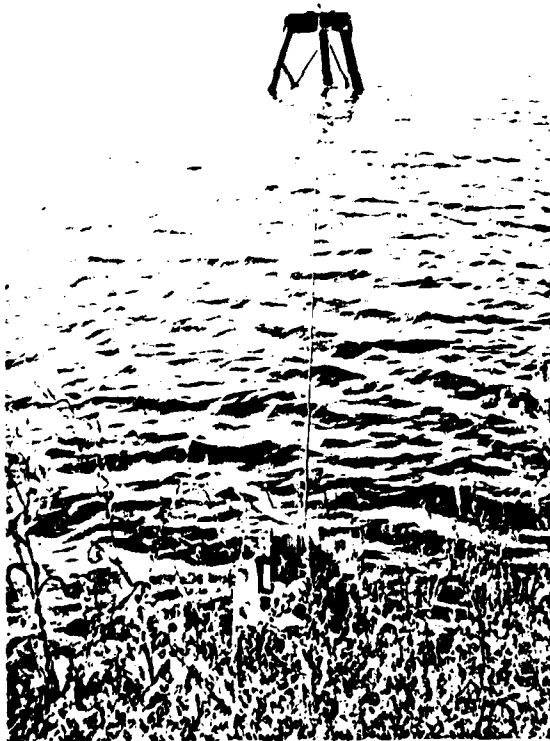
The hand winch and the top of the tripod structure in the reservoir were observed and seen to be in good condition. In the pump vault, the piping, pumps and valves were inspected and found to be in good operating condition. The outlet from the 4-inch gravity drain line was not located during the inspection.

Photo 8 - Picture of hoist arrangement for the water supply intake.

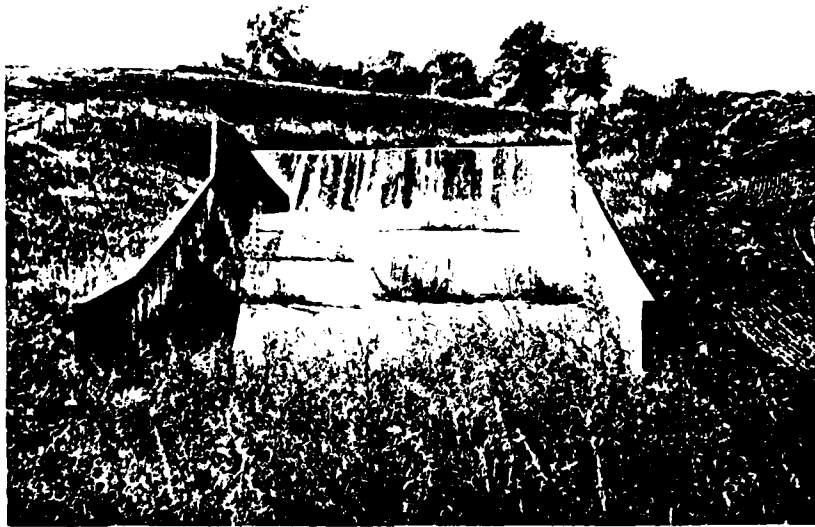
Photo 9 - Picture of emergency spillway taken from downstream.

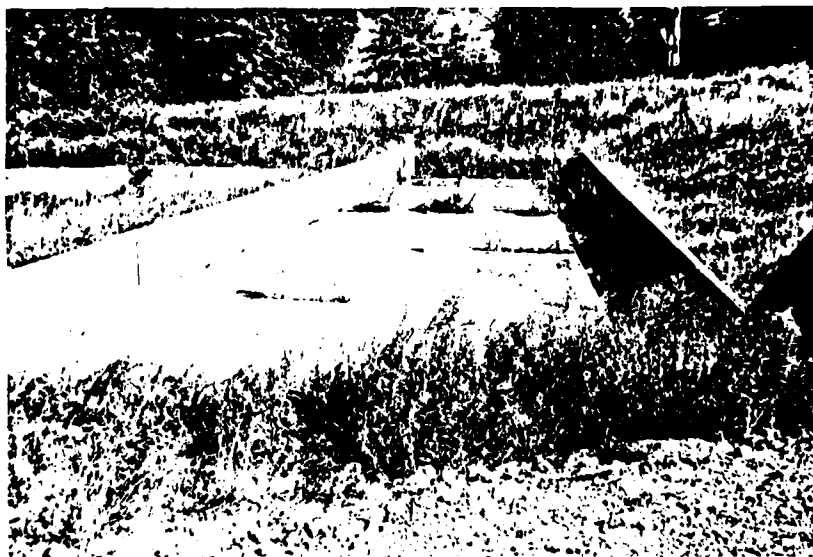
Photo 10 - Picture of emergency spillway and downstream channel taken from approach channel.

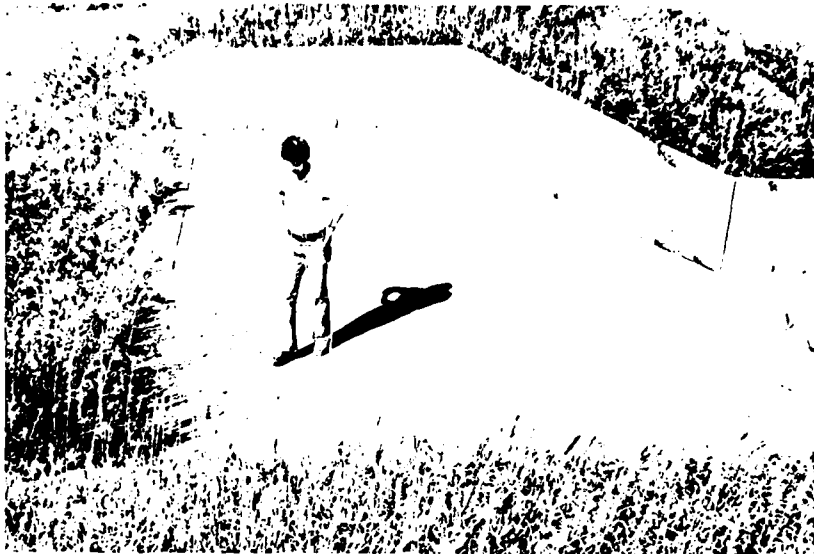
Photo 11 - Picture of spillway crest taken from right abutment.
